Consulting Report Breaker Trip / Fuse Blowing Investigation MCC / Blower Motors

Introduction / Background

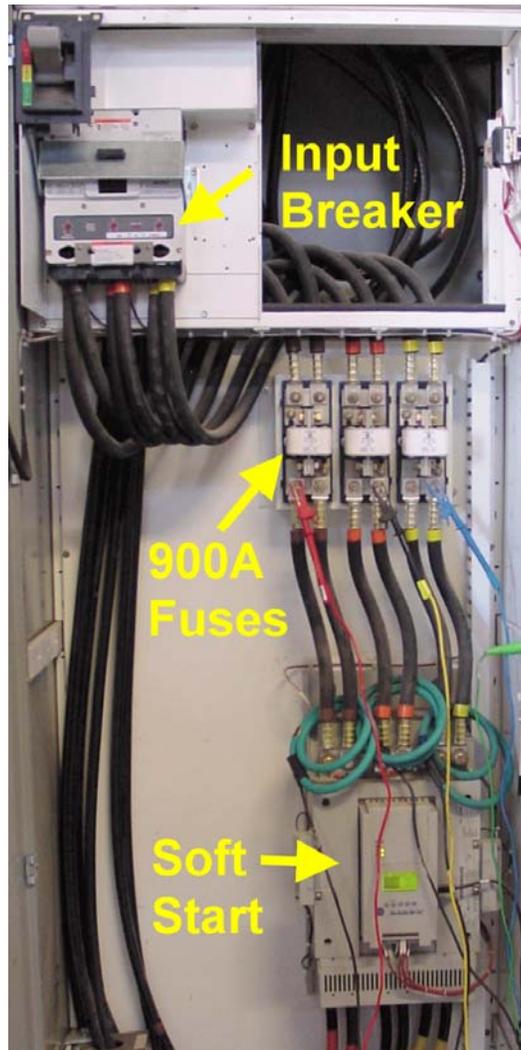
Photo 1 shows the MCC cabinet components—main input circuit breaker, fuses (phase A which has blown several times) and the soft-start.

Photo 1 - MCC cabinet showing components.

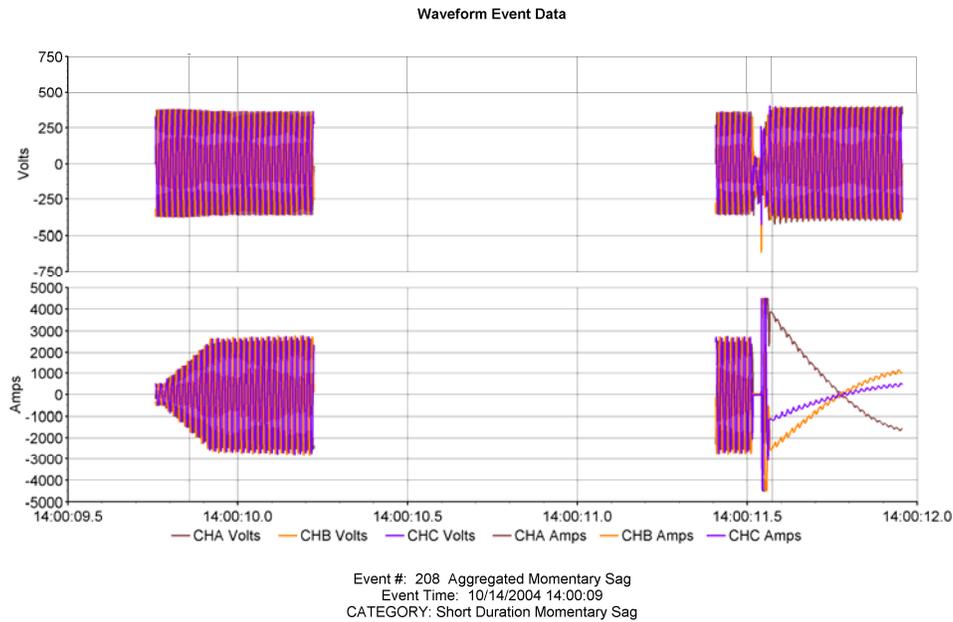
Figure 5 shows the waveform envelope associated with blower 4 tripping off at the time blower 3 was being started. Careful analysis of the waveforms indicates that after about 1.7-seconds (100-cycles)

something causes the Automatic Transfer Switch (ATS) switch to transfer to the alternate (second) source. At the time that the ATS closes on the second source a current surge, well above the instantaneous setting of 3000A for the MCC 600A input breaker, is experienced causing the 600A breaker in the MCC to trip.

Figure 5 – Waveform envelop at load side of ATS showing open transition and current surge associated with second source.

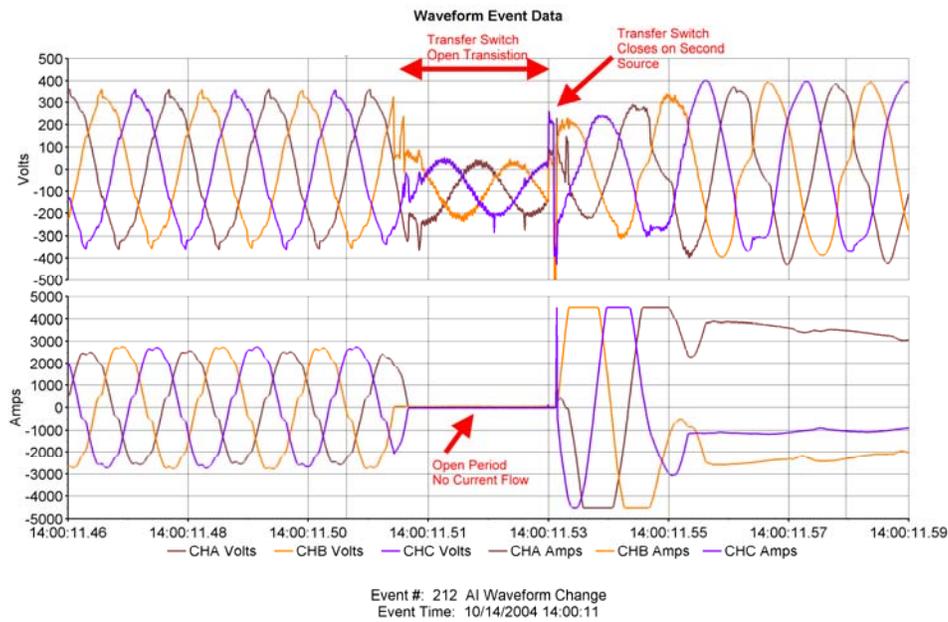
Figure 6 – Detailed waveform from figure 5 showing open transition and connection to second source.

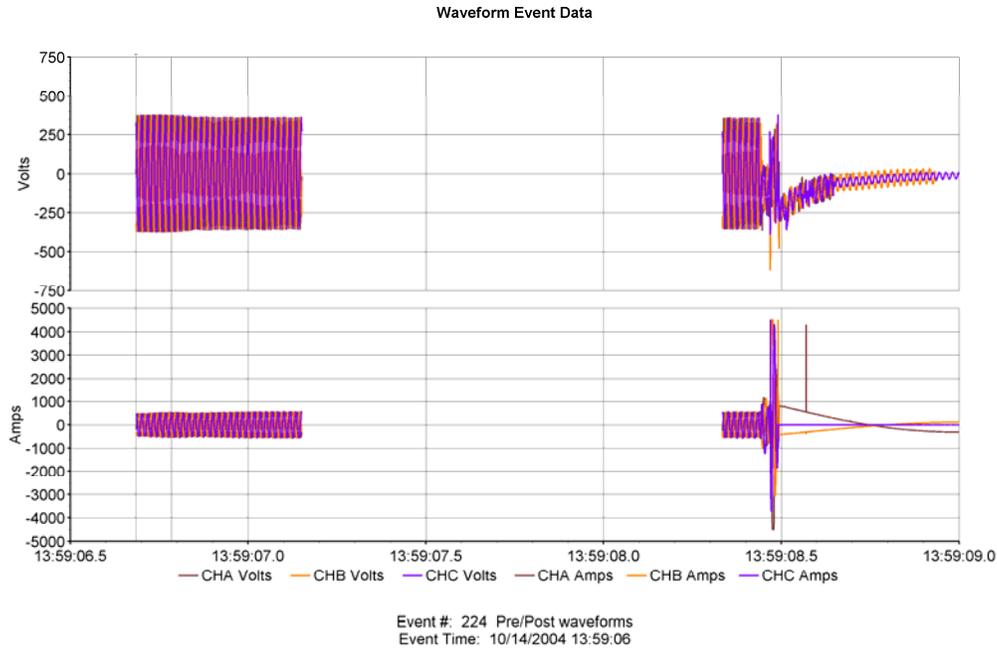
Figure 7 - Waveform envelop from MCC 4 at the time blower 3 was attempting to start. Note 4000+ Amp current surge that operated MCC 4 600A input breaker.

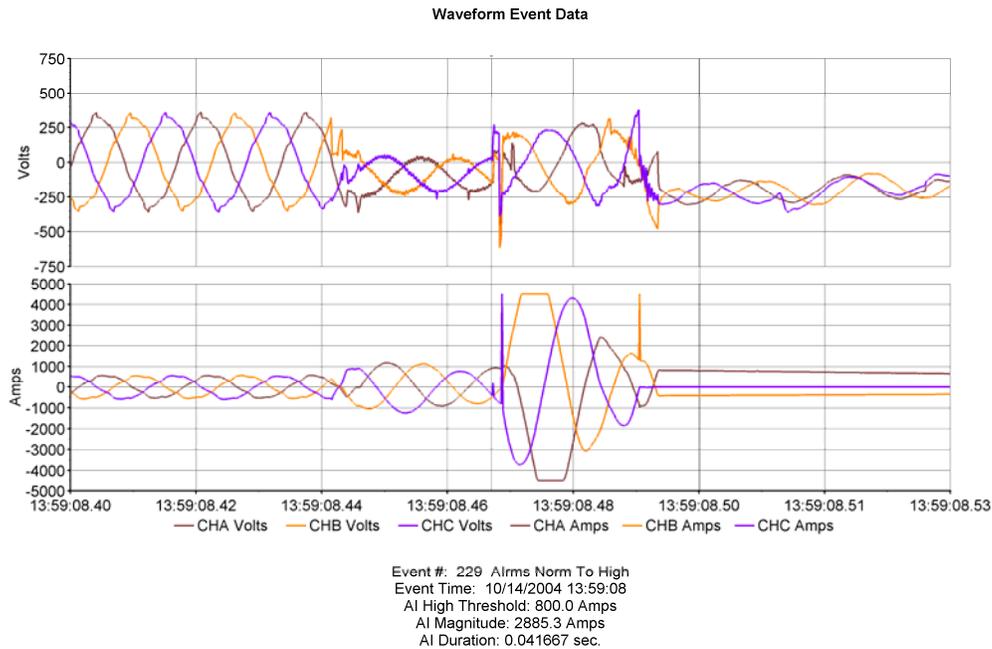
Figure 8 – Detailed waveform from figure 7 showing 4000+ Amp current surge.

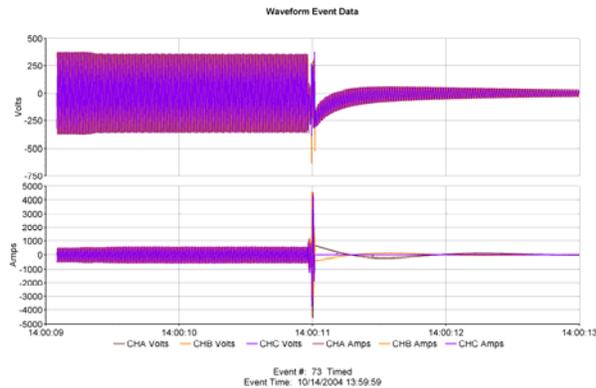
Figure 9 Waveform envelop of MCC 4 soft-start output at time of breaker tripping—refer to figures 7 and 8.

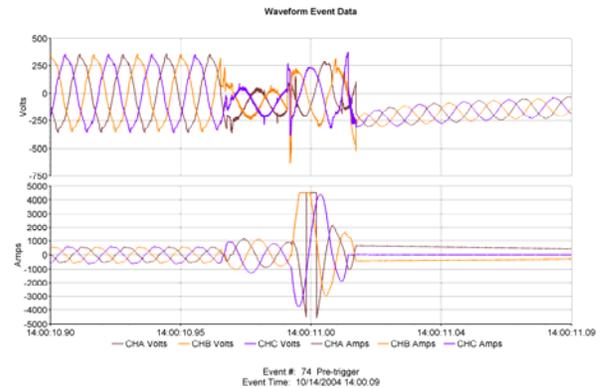
Figure 10 – Detailed waveform recorded on MCC 4 at the output of the soft-start at the time of breaker tripping—refer to figures 7, 8 and 9.

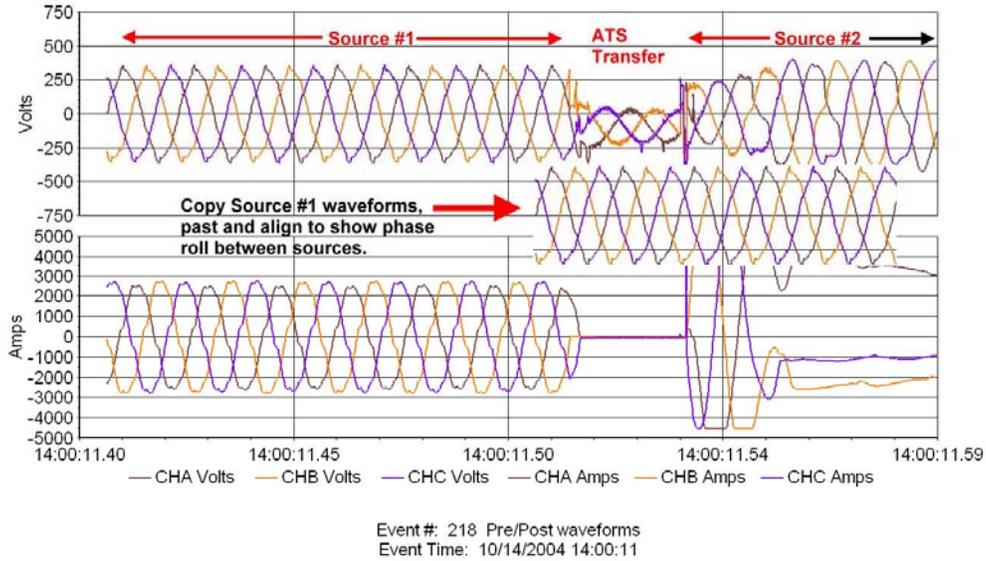
Careful analysis of the event waveforms recorded during the breaker tripping revealed that there appeared to be phase transposition (rotation/rolling) between the two sources—north and south utility feeds—connected to the ATS.

Figure 12 – Detailed waveform event data from failed start-up and breaker trip showing phasing problem between ATS sources. (Waveforms from source #1 were copied, pasted and aligned to better illustrate phase “roll” between sources).

RECOMMENDATION: (1) Correct the phase inconsistencies between the respective sources of the ATS. It is actually more like the phases were “rolled” (or rotated) as the correction involves all three-phases. The inconsistency could be in either of the sources (services) or the actual wiring of the ATS. While it is common practice to verify phase rotation it is no guarantee that the ATS inputs are wired with the proper phase relationships—as this experience demonstrates. Phase rotation should always be checked, and in addition a voltage reading should be made between corresponding phases of the respective sources—a near zero value should be obtained if the phase relationships are correct. In the case of the new ATS the readings of A to A, B to B and C to C were all in the 480V range indicating a phase relationship wiring problem. (2) Retest and document cycling of equipment in various modes following correction of ATS wiring.

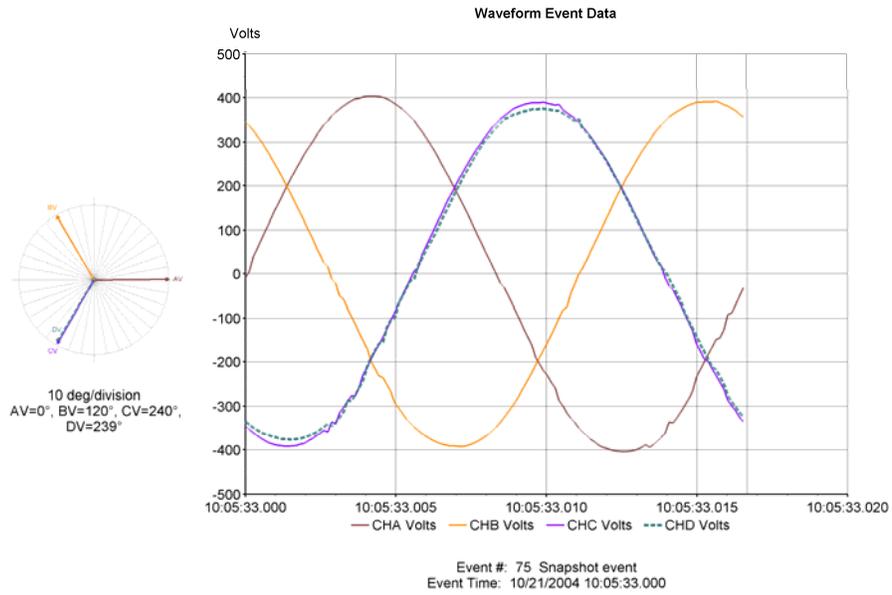
The results of the testing determined that while the phase rotation (ACB) is the same for both sources the relationship of the phases across the ATS is rotated 120-degrees. Figure 13 is a waveform graphic with phasor showing that phase A of source #1 is related to phase C on source #2. Photo 2 shows the relative ATS phase relationships for source #1 and #2.

Figure 13 – Voltage waveforms associates with ATS source #2 with channel D connected to phase A of ATS source #1 which tracks with phase C of source #2.

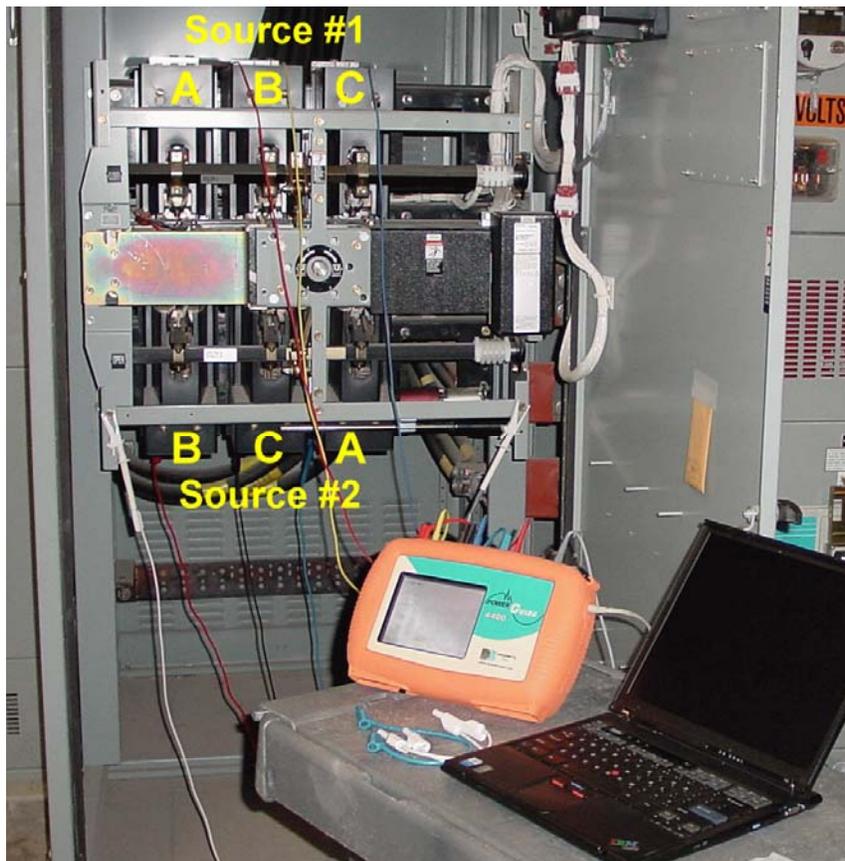
Photo 2 - New transfer switch showing phase termination rotation between sources.

There is a high likelihood that the blown fuse and breaker tripping experienced earlier are related to the wiring error associated with the new ATS. Both the ATS and the controller (PLC) for each blower have various thresholds settings and they may be set a little sensitive for this application and certainly need to be coordinated.

CORRECTIVE ACTION / DISPOSITION: The Utility Department rolled the phases associated with the south feed transformer to correct the phase inconsistencies between the sources of the new ATS. A Dranetz-BMI PowerGuide 4400 was connected to each source of the new ATS to verify correct phase relationships and phase rotation after completion.
