PowerCET Corporation  
3350 Scott Blvd., Bldg. 55 Unit 1  
Santa Clara, CA 95054  
Voice: 408/988-1346  
Fax: 408/988-4869  
E-mail: [consulting@powercet.com](mailto:consulting@powercet.com)  
URL: <http://www.powercet.com>

## Consulting Report ATE Product Testing Lab Noise Problem ABC Industries Somewhere Valley, AK

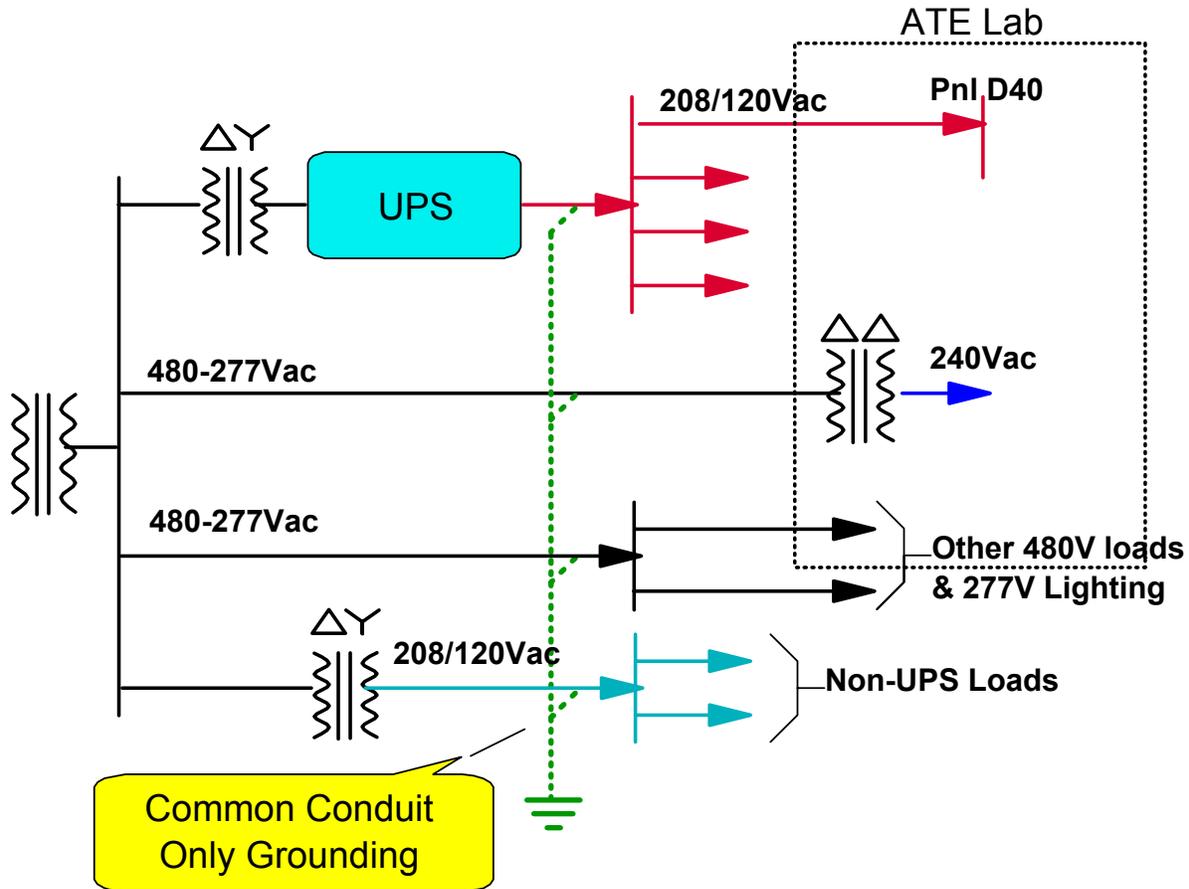
Figure 1 is a graphical attempt to illustrate present grounding and distribution system with common conduit connection. The mounting brackets for the conduit are common which effectively ties all electrical systems together through the building. The result is that interference generated anywhere in the building has the potential to flow through the various conduits in the ATE Lab area.

In addition the integrity of the equipment grounding system is dependent on the various physical connection methods used in the construction of the electrical system—screw thread, clamp, compression sleeve, etc. All of these methods of connection have their problems and should never be used as the sole grounding means in an electronic installation.

Figure 1 - ABC facility electrical distribution--conduit only grounding.

All future construction specifications for the buildings electrical distribution system should specify that appropriately sized ground conductors be installed in all conduits along with the current carrying conductors. This serves two purposes: (1) in the event of electrical faults on an associated circuit the equipment grounding conductor will carry the highest level of fault current and limit (lower) the propagation of interference signals in the remainder of the conduit system and (2) the quality of the equipment grounding system will be improved as the integrity of the system will no longer depend on screw-thread, clamp and compression sleeve connections as the only ground means.

Future building specifications for electronic environments should also include the requirement for equipment ground conductors—specifically, do not rely on conduit only grounding. Electrical distribution for all future construction should employ dry-type delta-wye distribution transformers to create zones of interest, and limit interference and zero-sequence harmonics from propagating throughout the buildings electrical distribution. The transformer requirement is especially critical for laboratory—ATE, Environmental, EMC, etc.—areas which all should be served from individual transformers. (See recommendation for ATE Lab below.)

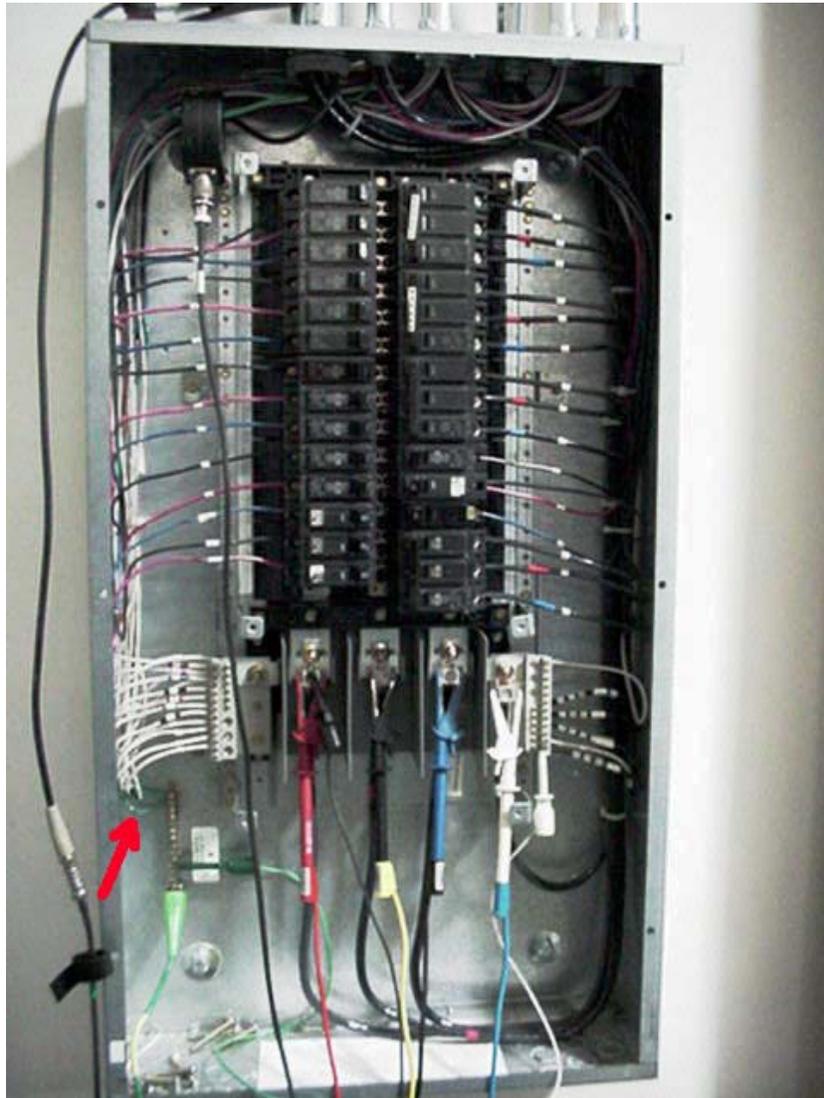
A visual inspection of panelboard D40 revealed circuits 22-24-26 were installed with a green-wire grounding conductor (isolated ground). The associated circuits terminated in the Environmental Lab across the hallway. Further inspection of the duplex receptacles installed on the circuits found one that was NOT an Isolated Ground (IG) type and this resulted in connection of the conduit grounding system with the Isolated Ground conductor terminated in D40. (Facility electricians removed the offending duplex receptacle at approximately 3:10PM on 4/27/2000.)

Photo 1 below shows the offending green wire IG conductor—red arrow. (See recommendations for practices regarding installation of branch circuits between zones.)

**Photo 1- Panelboard D40 ATE Lab showing green wire IG conductor terminating in Environmental Lab across the hallway.**

The practice of installing branch circuits where they originate in one lab (sensitive area) and terminate in another lab—as was the case with the IG circuits 22-24-26 in panelboard D40 (ATE Lab)—should be avoided. Installing circuits, which run between zones of interest compromise the electrical integrity (at least from an interference standpoint) of both lab areas.

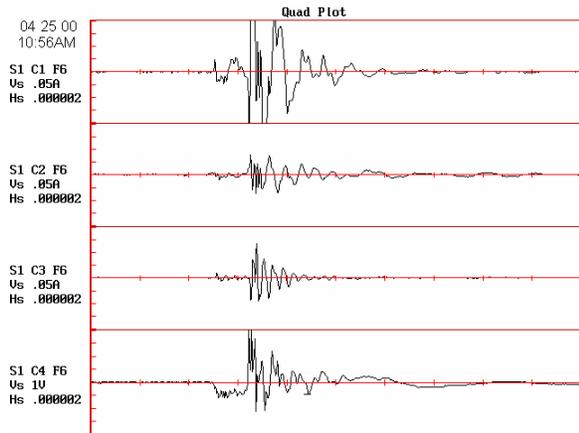
In Figure 2 channel 1 is the signal on the IG conductor that terminated on the receptacles from the Environmental lab the corresponding signals on the grounds, channels 2 and 3, associated with the TS4 test station demonstrate how the signal propagated in the conduit grounding system. Channel 4 is the corresponding neutral-to-ground voltage in the 5kHz-5MHz bandwidth.

The Dranetz-BMI 658 Power Quality also recorded a series of neutral-to-ground voltage impulses at the same time as the event in Figure 2, the largest of which was approximately 51 volts peak-to-peak—see Figures 4 and 5. Figure 4 is the neutral-to-ground event and Figure 5 is an expansion of the largest of the impulses in Figure 4. There was not a corresponding line-to-neutral event recorded which indicates that the signal is ground based—HF current probes confirm the current flowing in the various grounding conductors and conduit.

**Figure 2 - High frequency ground based interference. Ch1=Ground current in D40-Ckts 22-24-26 green wire ground; Ch2=Ground current in LT Flex to TS4; Ch3=Ground current in green wire in power panel of TS4; and Ch4=Neutral-to-Ground voltage in D40 (5kHz-5MHz bandwidth).**

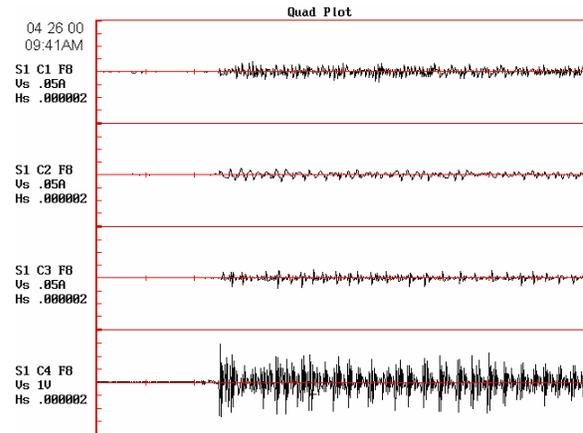
Figure 3 is an event, which was recorded at 9:41AM on 4/26/2000, and in this instance the monitoring system was connected to the XYZ/TS test station with channel 3 monitoring the TTL data link between the test station and the UUT (Unit Under Test). Again there are significant signals present on the other grounding conductors—channels 1 and 2—as well as a voltage signal recorded on channel 4—neutral-to-ground at panelboard D40. This signal is the type that has the capability to disrupt digital communications signals because of the duration and the burst (repetitive) characteristic. In all likelihood the path through the TTL link and UUT is capacitively coupled, as the signals appear to have higher frequency characteristics—shorter rise-times. (Note: This characteristic was noted in other recorded interference signals on the TTL data link.)

**Figure 3 - High frequency ground based interference. Ch1=Ground current in D40-Ckts 22-24-26 green wire ground; Ch2=Ground current in LT Flex to XYZ/TS; Ch3=Interference signals in TTL data link between test equipment and UUT in XYZ/TS; and Ch4=Neutral-to-Ground voltage in D40 (5kHz-5MHz bandwidth).**

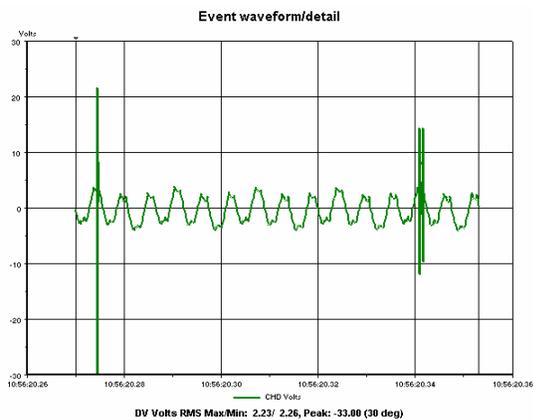
**Figure 4 - Neutral-to-ground power monitor event corresponding to signals in Figure 2.**

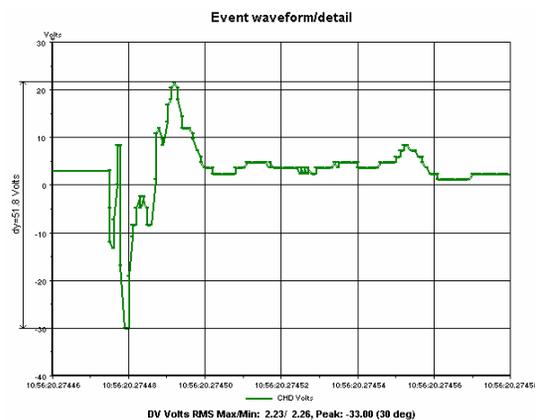
**Figure 5 - Expanded neutral-to-ground power monitor event depicted in Figure 4.**

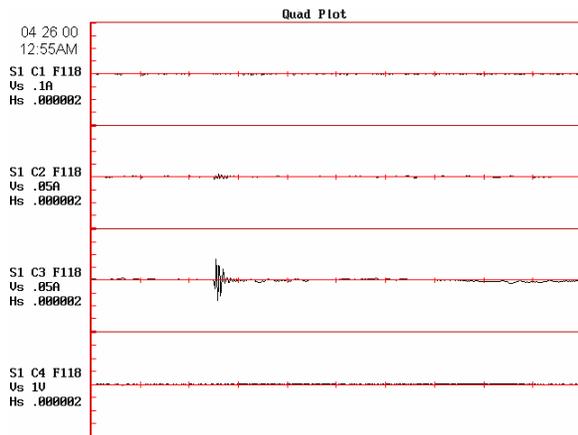
In Figure 6 the only significant signal recorded was on channel 3, which is the TTL data link on test station TS4. The graphic to the right, Figure 7, is an expansion of the signal on channel 3 from Figure 6. The ringing frequency of the recorded events ranged from approximately 5MHz to 8MHz and may be alisased. The lack of significant signals on the other channels indicates that the source of interference recorded on channel 3 may be in the test station equipment.

**Figure 6 – Interference signal (current) on TTL data link TS4 test station.**

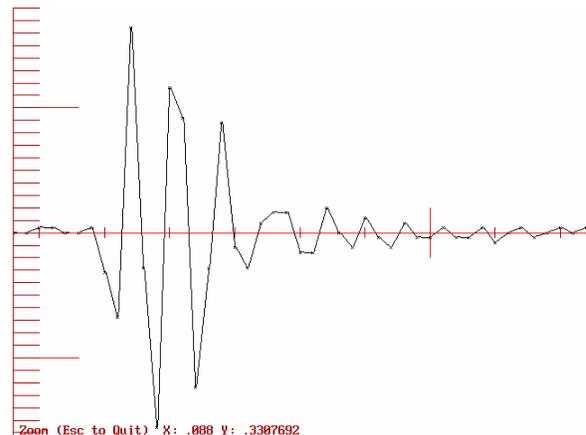
**Figure 7 – Expansion of signal (current) on channel 3 from Figure 6—TTL data link.**

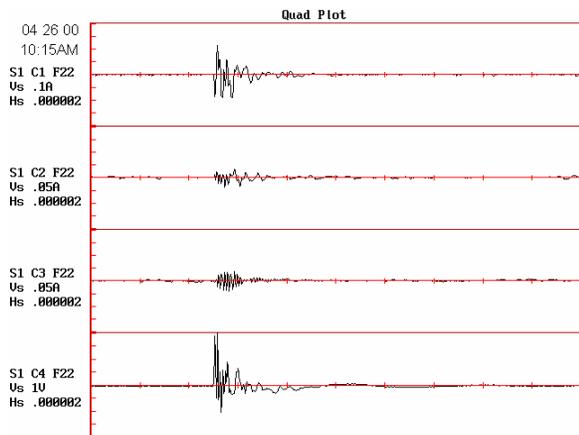
Figure 8 is a set of signals similar to those in Figures 2 and 3 in that they are entering the ATE Lab via the equipment grounding (conduit) system and then propagated throughout the area including the TTL data link. Figure 9 is an expansion of the signal on channel 3,

**Figure 8 – Interference signals associated with ATE station TS4.**

The MainEvent monitoring data confirms the presence of a complex series of ground loops associated with the buildings electrical distribution—specifically the building conduit system. This situation combined with the extension of branch circuits from panelboard D40 to the Environmental Lab across the hallway appears to have created a significant signal path into the ATE Lab. Removal of the IG to conduit connection in the Environmental Lab appeared to significantly reduce the levels of interference during the last part of the monitoring activity.

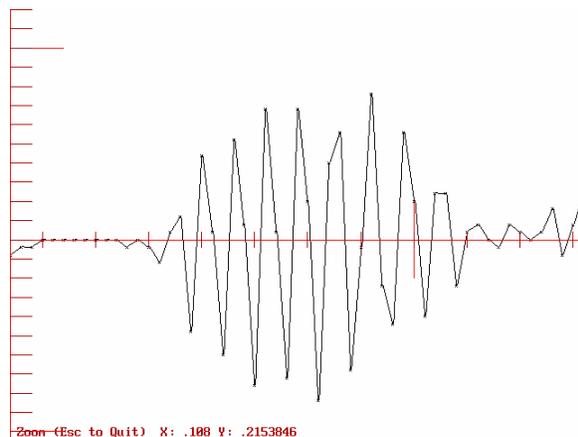
**Figure 9 – Expanded interference signal, channel 3, TTL data link test station TS4.**

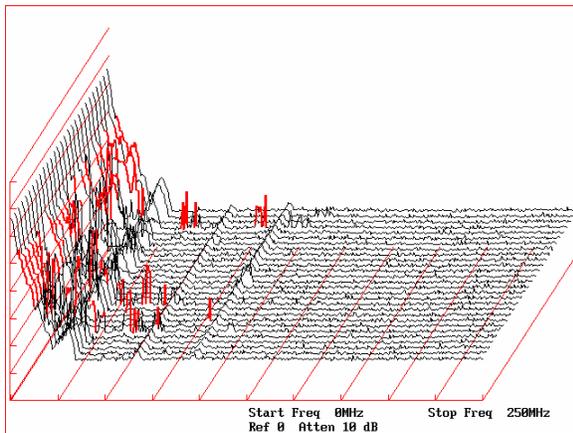
The following two figures, 10 and 11, are waterfall plots of the recorded data from the spectrum analyzer. Each trace represents a peak-hold from a 5-minute period of time. The red highlighted signals represent levels 10% above the average. The frequency spectrum (x-axis) events are grouped on the left side (lower frequency) and are consistent with the frequency characteristics of the recorded signals. (Note: The 3dB bandwidth of the current probe used is 10kHz to 100MHz so the few signals above 100 MHz are not represented accurately.)

The signals represented by these graphs are being conducted through the LT flexible conduit connection to the test systems and may not be representative of the signal levels in other parts of the facility. Also the duration of the monitoring period was short and the recorded information may not represent conditions when other nearby labs are running experiments.

**Figure 10 – Spectrum analyzer waterfall plot from initial monitoring session on 4/25/2000.**

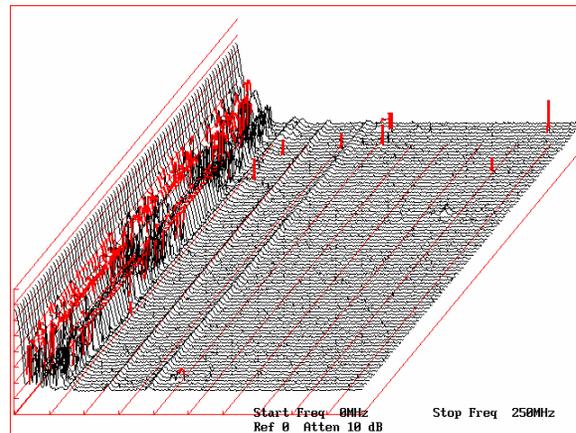
**Figure 11 – Spectrum analyzer waterfall plot from 4/25/2000 @ 1:43PM through 4/26/2000 @ 9:43AM.**

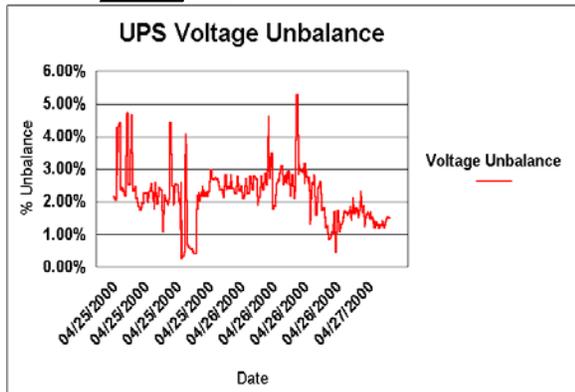
The following graphic, Figure 12, is a record of the phase voltage unbalance recorded at panelboard D40 in the ATE Lab area. Generally voltage unbalance levels above 3% are considered points where corrective action is recommended. Voltage unbalance as low as 2% can impact the operation of some motor drives. Higher levels of unbalance can cause premature electric motor failure or inconsistent operation.

**Figure 12 – UPS voltage unbalance.**

The first item is the voltage unbalance between phases, which is nominally between 2% and 3%-- normally an action level. Peak levels of voltage unbalance as high as 5% were recorded during the monitoring period.

The cause of the voltage unbalance is most likely a single-phase load condition where one, or more, phases have excessive single-phase loads connected. It could also be a problem with the UPS output inverter and/or filter capacitors.

- Inspect and test UPS output filter capacitors—infrared thermography can sometimes be used to ascertain the condition of the filter capacitors (look for the cold ones).
- Monitor and determine phase voltage unbalance levels at UPS output and verify load balance on major UPS distribution feeders.
- Review loads connected to UPS power system—remove non-critical loads that do not require UPS power.
- Monitor and determine harmonic content at UPS output—voltage and current.
- Based on findings from above activities develop a mitigation program to improve (decrease) harmonic voltage distortion and restore phase voltage balance.

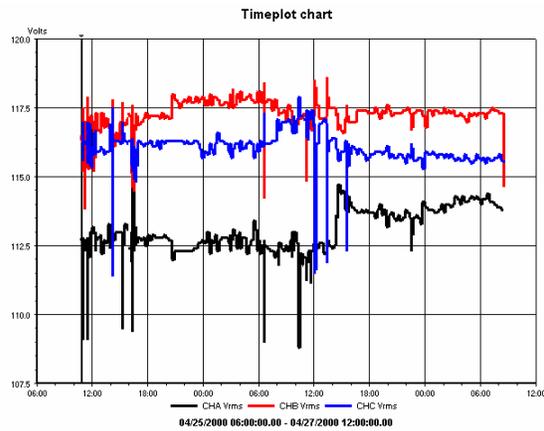
**Figure 13 – RMS voltage timeplot.**

Figure 13 (above) is a timeplot of the RMS voltage levels recorded at panelboard D40 over the duration of the monitoring period, which was the basis for the unbalance calculations illustrated in Figure 12.

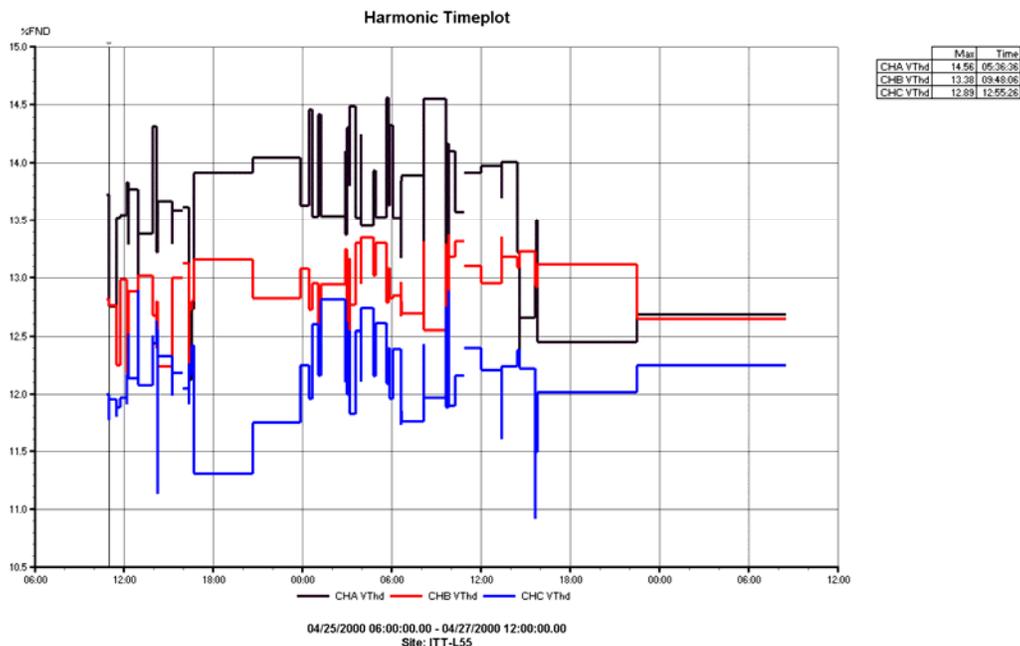
The voltage waveform distortion of the UPS power system is excessive.

During the monitoring period the Vthd ranged from 11% to over 14%. A level of between 6% and 10% is generally considered the area where corrective action is recommended. The dominant cause of the voltage distortion is the load interaction between the single-phase switch-mode power supplies (computer type loads) and the output impedance of the UPS inverter section. Figure 14 is a timeplot of the voltage total harmonic distortion (THD) over the duration of the monitoring period. Figure 15 is a representative sample of the voltage waveform demonstrating both the phase unbalance and the waveform distortion.

**Figure 14 – Voltage distortion timeplot.**

Some of the distortion may be the result of the bad output filter capacitors on the Exide UPS.

A harmonic study will be required to determine the specific cause of the distortion and provide information for evaluating various mitigation options. Any study should include an evaluation of the service life for the existing UPS equipment and consideration of the replacement UPS as part of a harmonic mitigation plan. It may be more cost effective to delay significant harmonic mitigation until the change out of the existing UPS equipment and then switch to a 480V UPS model and use 480-208/120V delta-wye distribution transformers to control zero sequence harmonics and limit propagation of interference in the general facility.

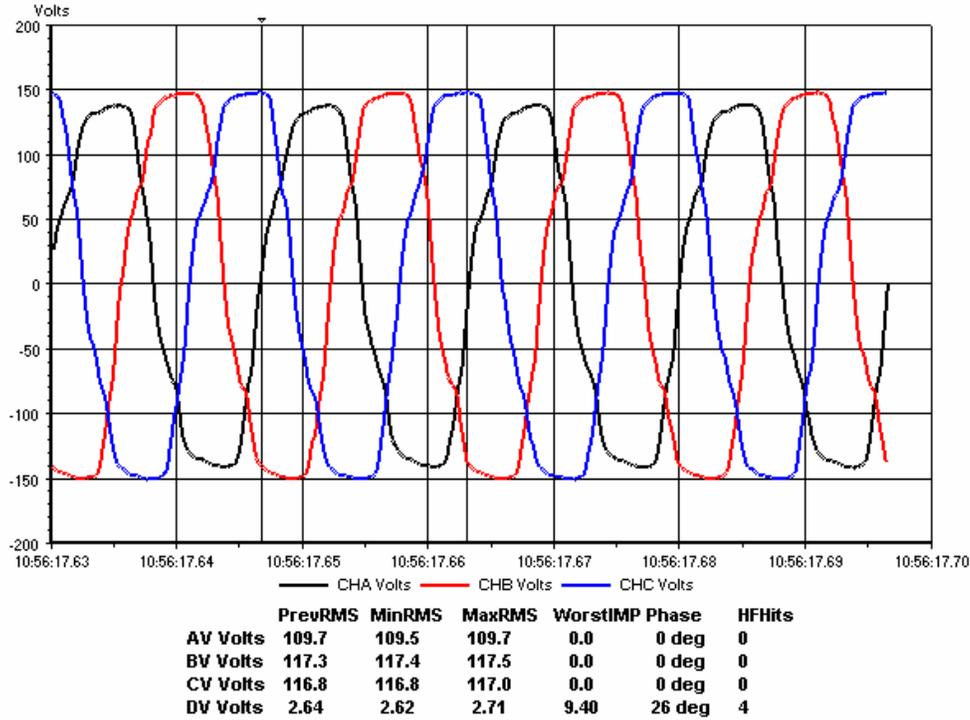
**Figure 15 – Voltage waveforms showing phase unbalance and waveform distortion.**

The peak value of the 120Vrms supply is approximately 150Vpeak, which is a 12% decrease in voltage available to drive the various electronic loads.

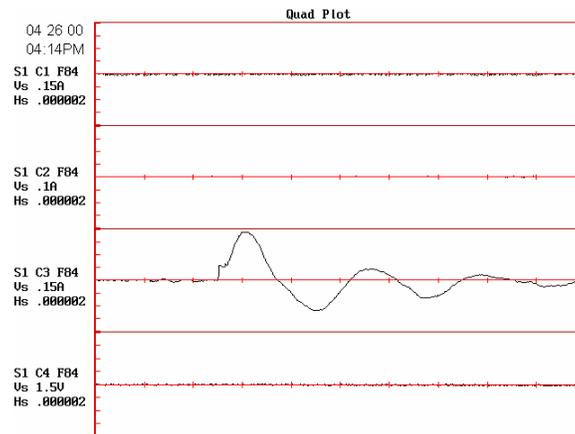
The following figure is a recording of the current flow in the TTL data link that seems to coincide with energizing the interface—see Figure 16. The signal is only present on channel associated with the TTL data link and was recorded by the monitoring equipment on several occasions when the interface was activated. This is probably a normal situation associated with the testing process and not associated with the communications problems being experienced at other times.

Figure 16 – TTL data link event at time of interface activation.

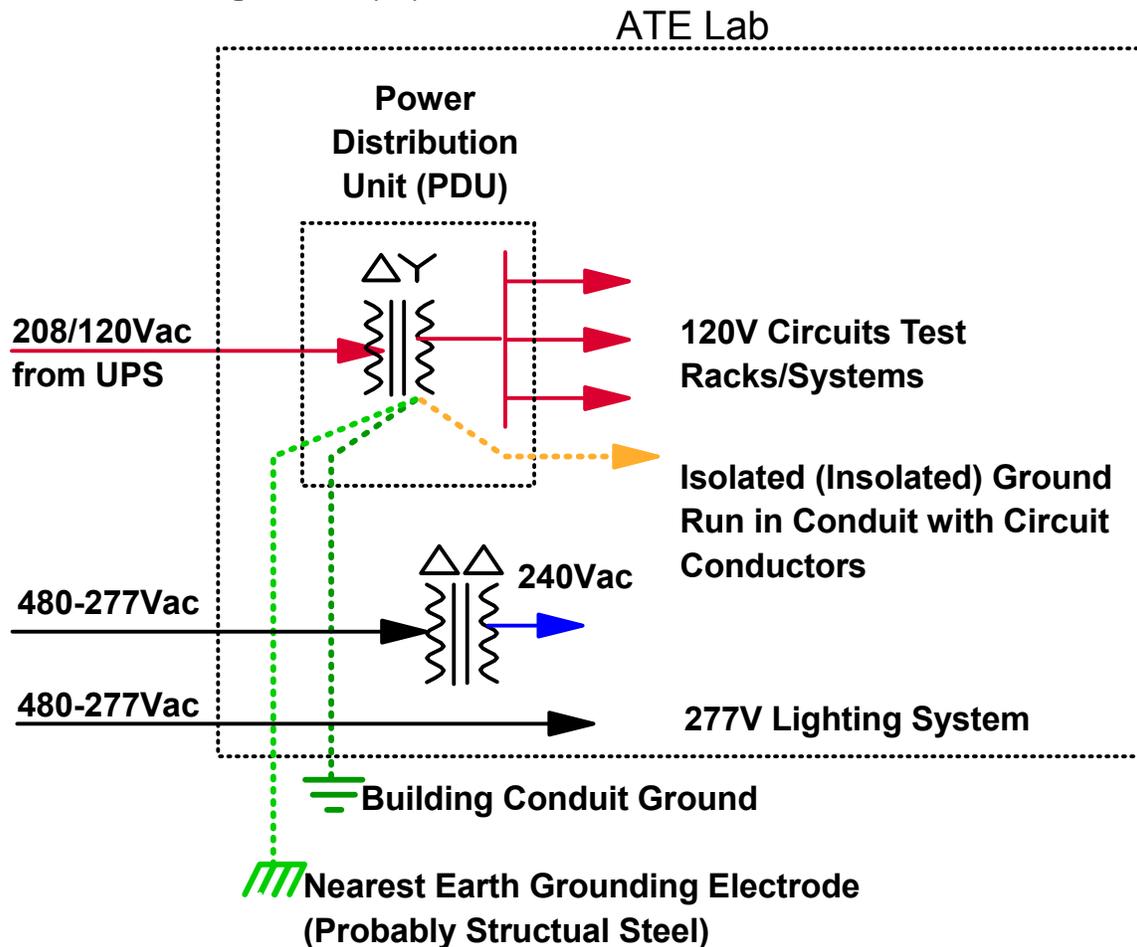
Figure 17 below is a diagram of the proposed electrical distribution for the ATE Lab.

**Figure 17 – Proposed electrical distribution for ATE Lab with PDU.**

The objective of any mitigation activity should be to establish a separately derived electrical supply serving the electronic test systems in the ATE Lab. Further it will be necessary to insulate the electrical distribution connected to the test bays from the building conduit system. This program can best be accomplished through the installation of an isolating—delta-to-wye transformer—Power Distribution Unit (PDU) adjacent to the D40 panelboard. The electrical distribution on the secondary of the PDU should be via liquid tight flexible conduit—care should be taken to ensure that the PDU distribution does not come in contact with the building conduit system or other extraneous grounds.

The PDU equipped with the delta-wye transformer provides for a neutral-ground bond on the secondary as well as a capacitive filter output to attenuate transients and load interaction within the ATE Lab area.

In addition to providing noise filtering and a new electrical system reference (neutral-ground bond) the delta-wye transformer in the PDU will provide some harmonic relief to the Exide UPS equipment. The zero sequence harmonics (3<sup>rd</sup>, 9<sup>th</sup>, 15<sup>th</sup>, etc.) are converted to balanced harmonics, dominantly 5<sup>th</sup> and 7<sup>th</sup>, through the phase relationships between the delta primary and wye secondary.
