Consulting Report Breaker Trip / Fuse Blowing Investigation MCC / Blower Motors

Introduction / Background

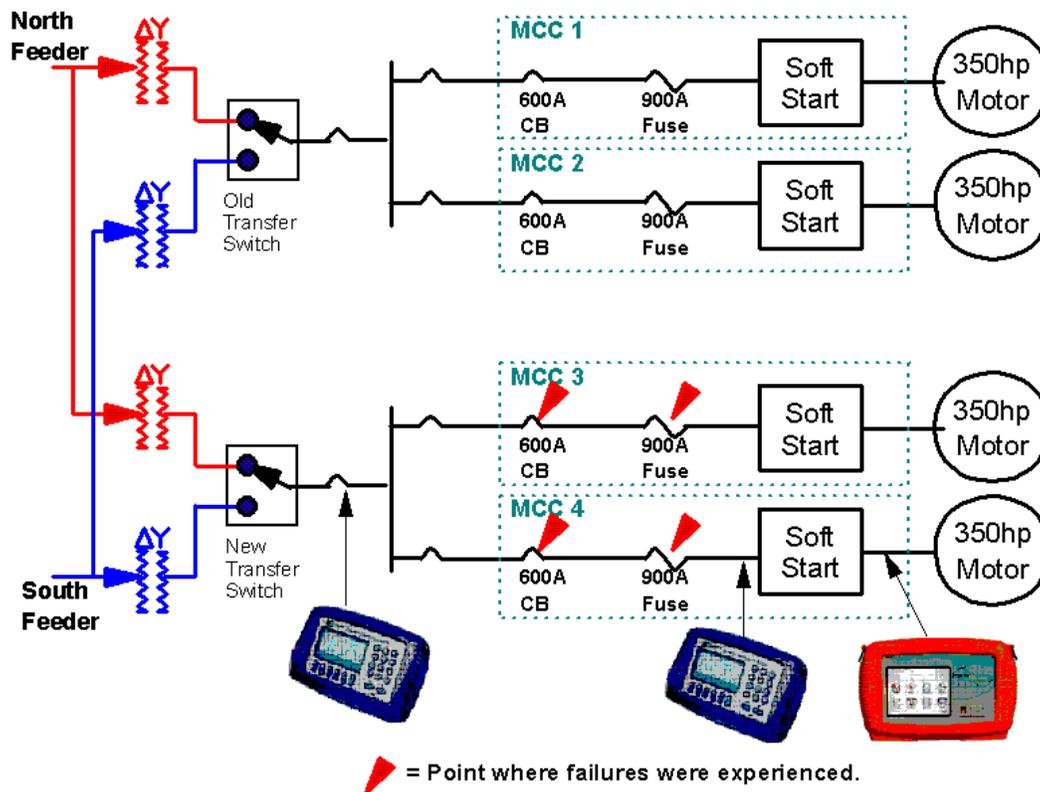
Figure 1 - Simplified diagram of blower electrical distribution.

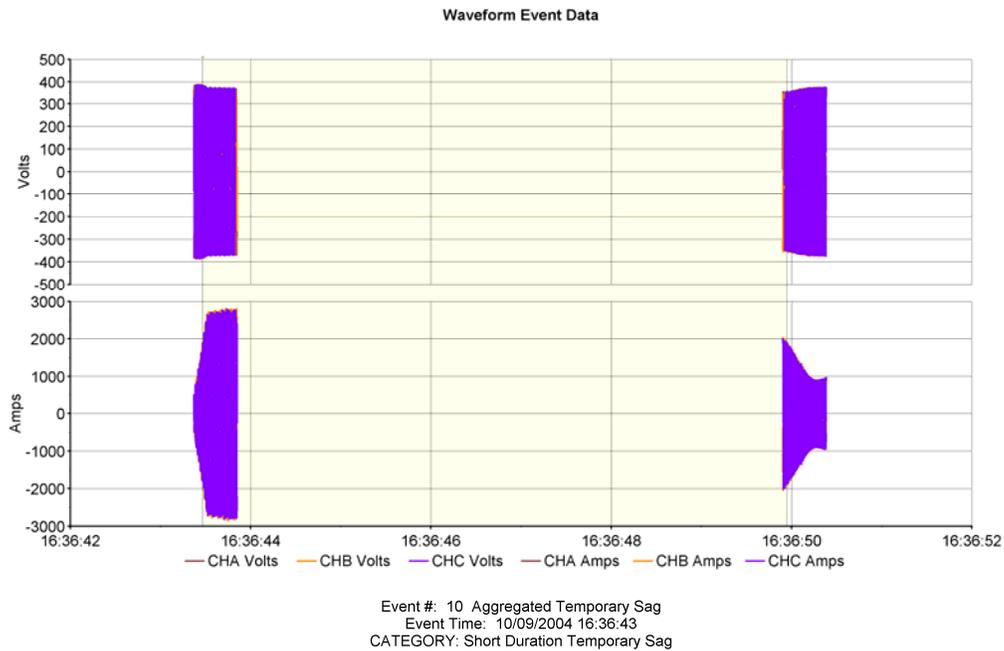
Figures 2, 3 and 4 show the waveform envelope and associated inrush voltage and current waveforms of a normal (successful) start-up of a second blower with one blower already operational.

Figure 2- - Waveform envelop of normal successful start with a second blower already operating.

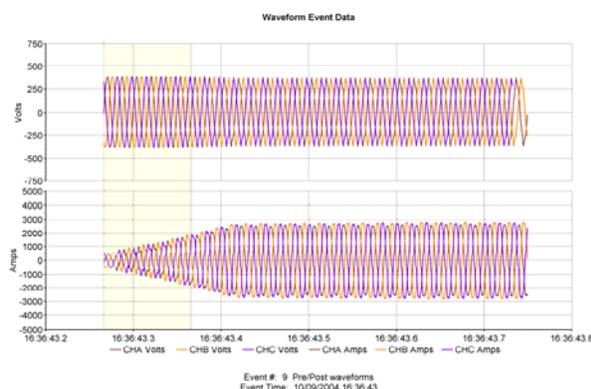
Figure 3 - Inrush waveforms for start-up of blower--see figure 2.

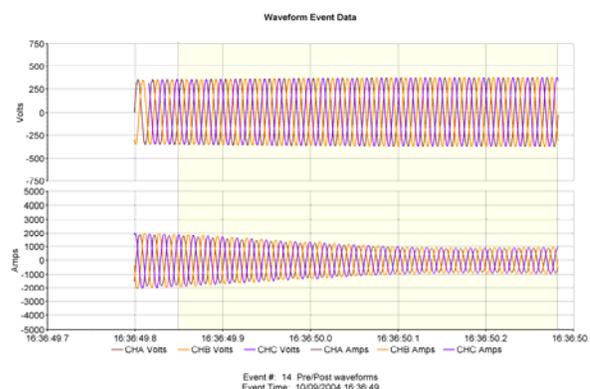
Figure 4 – End of inrush for start-up of blower—see figure 2.

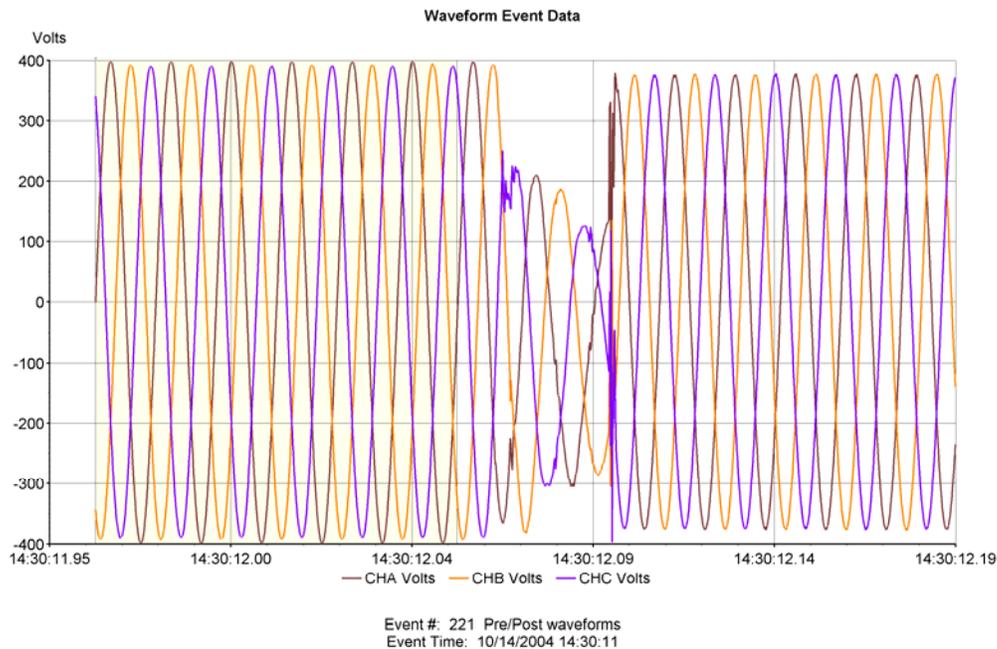
Figure 11 – ATS return to preferred source approximately 30-minutes following blower failures at 1400Hrs.—refer to figures 7 through 10. The retransfer back to the preferred source was programmed option.

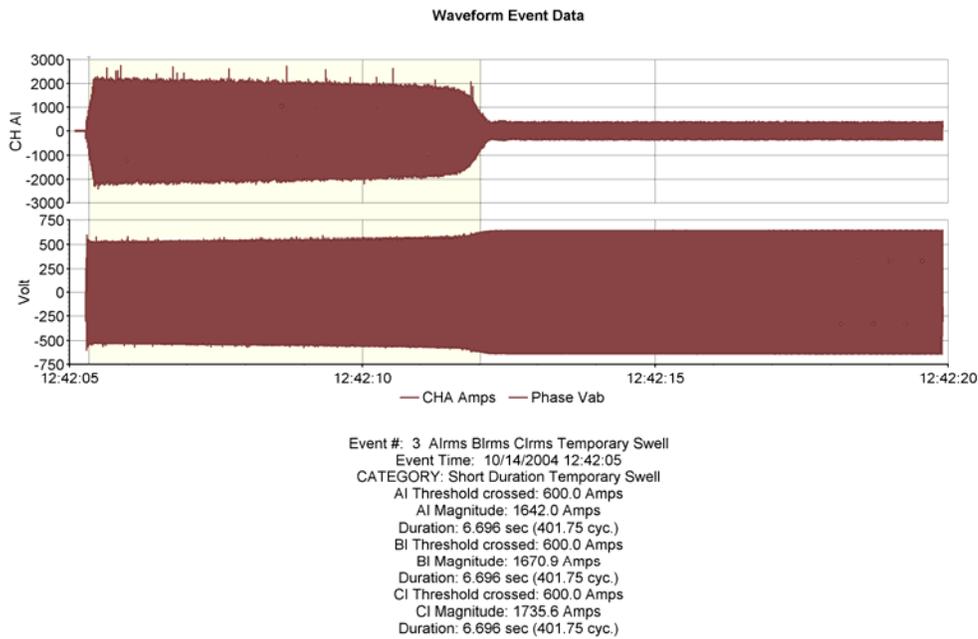
Figure 14 - Waveform envelop for normal start-up of blower 4. Measurements taken at output of soft start.

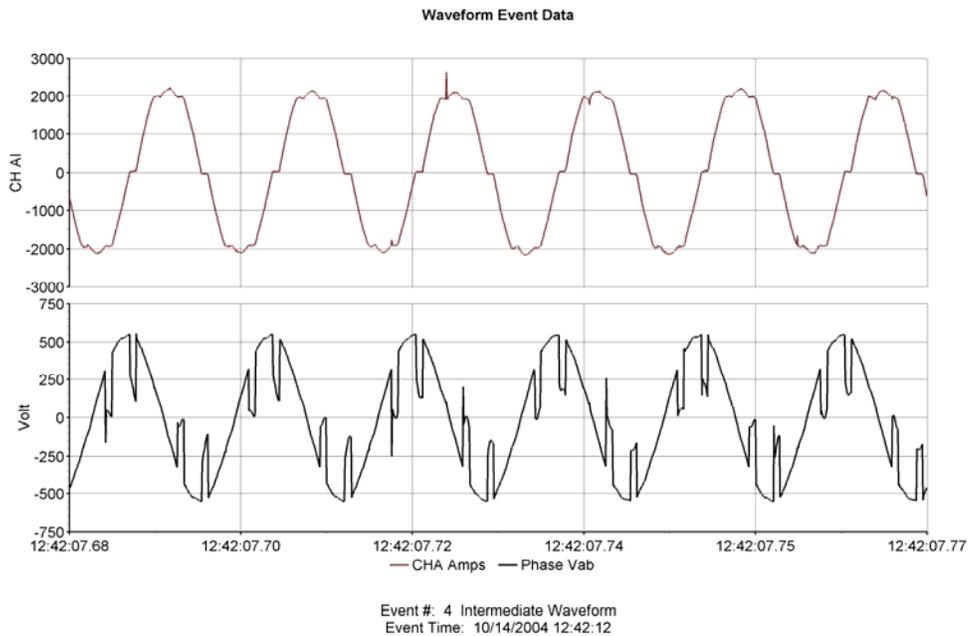
Figure 15 - Current and voltage waveform during inrush with soft-start active. Measurement taken at output of soft-start.

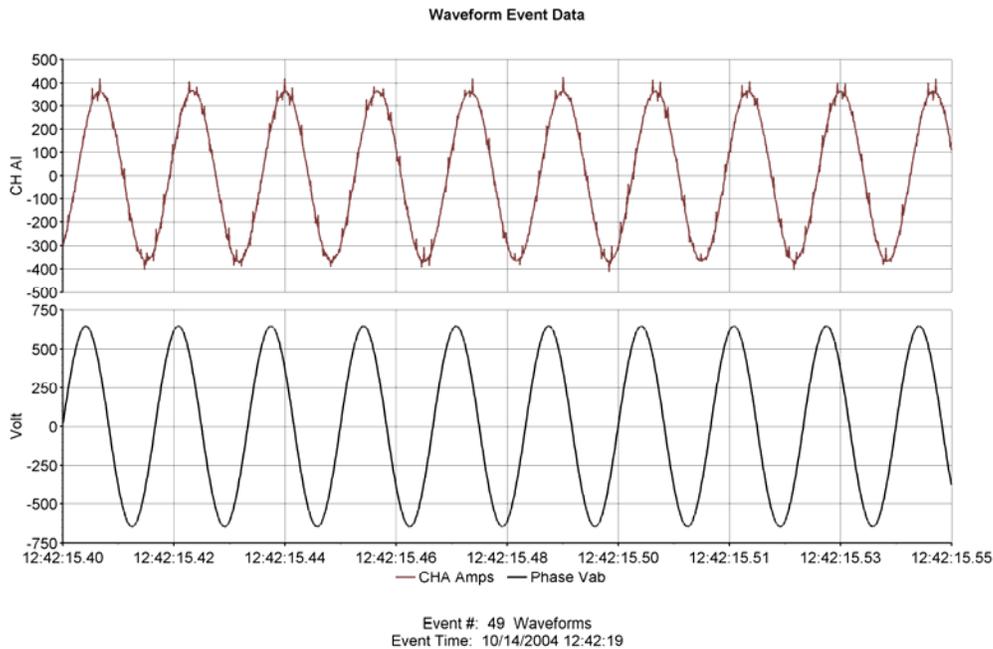
Figure 16 - Current and voltage waveforms during normal blower operation after inrush and soft-start operation. Measurement taken at output of soft-start.

COMMENT: The performance of the soft-start was documented, at the request of the client, as there was some initial concern that the problem may have been associated with “harmonics” at the output of the soft-start. There is a tendency “rush to judgment” and blame harmonics for most any problem that is not immediately obvious.

RECOMMENDATION: Design and install a permanent power monitoring network for the facility.
